Quinquennial Report

Kyleakin Church

Church of Scotland Lochcarron and Skye Presbytery
October 2016

PROPERTY KYLEAKIN CHURCH

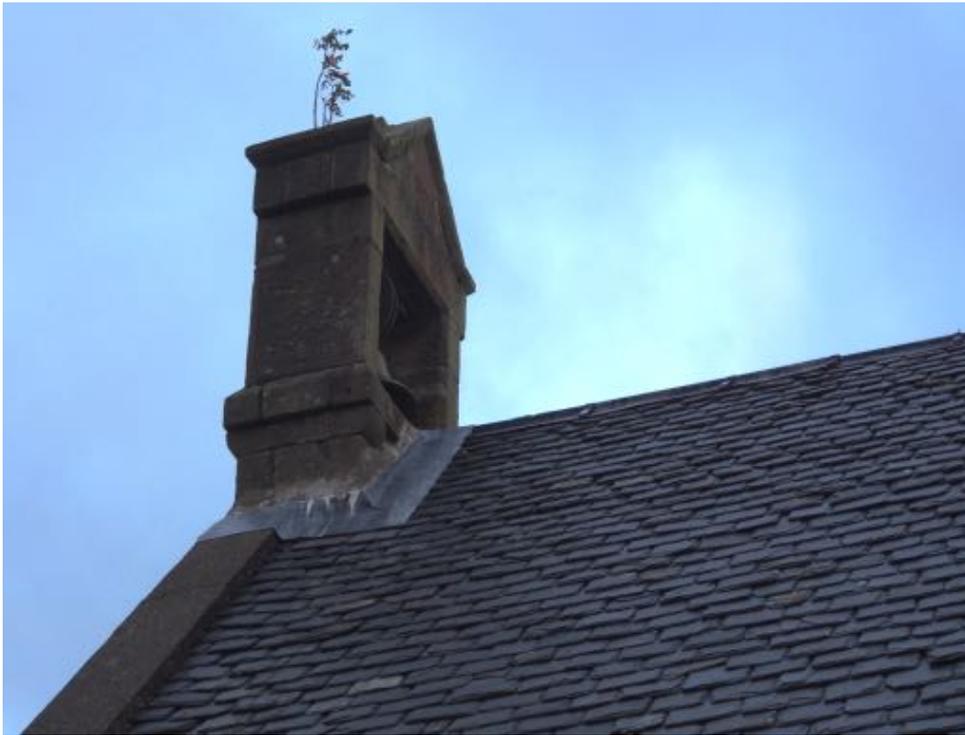
Bellcote with plant growth

ELEMENT	DESCRIPTION	CONDITION	RECOMMENDED REPAIRS	PRIORITY	COST
Spire, bellcote, finials	Sandstone bellcote with bell in place, at west gable of church.	Vegetation growth and open joint in top face of stonework	Remove vegetation and re-point	E	500
WALLS	Stone built church with cavity blockwork to hall extension				
Wall structure	Stonework to church walls Extension has cavity blockwork walls	Minor cracks under 2 no. windows on south side, and under middle window on north side, together with the blocked up opening of the east door. South gable has 2 no. movement cracks at either side. There is also a crack behind the downpipes at the east elevation.	Pick and point. Cracks in extension require repair to render finish	E	500
Wall finish	Stonework to church is thickly pointed and has paint finish. The west gable end is cement rendered, cills and ingress are also rendered. The hall has wet dash render with paint finish.	The gable end of the church has several patches of boss render, on the south elevation there is a crack to the window ingo and cement finish to cills is in moderate to poor condition.	Patch repair to boss render at church gable end and cracks to hall as noted above. Repair pointing to ingoes and cills	E	500

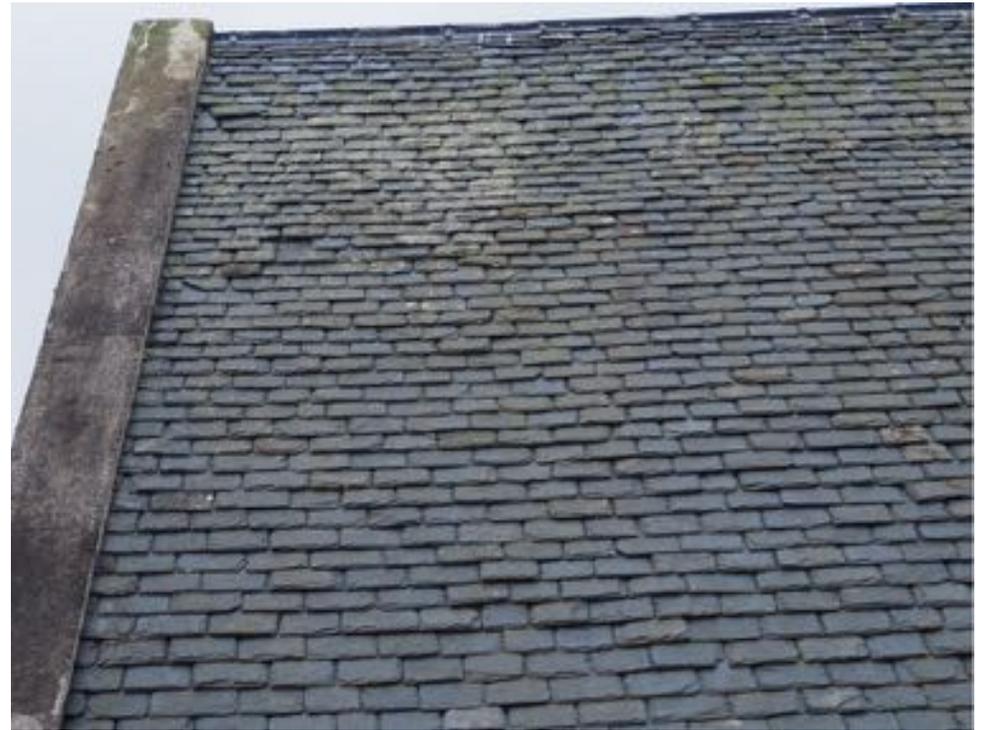
Slate roof at north east side of church

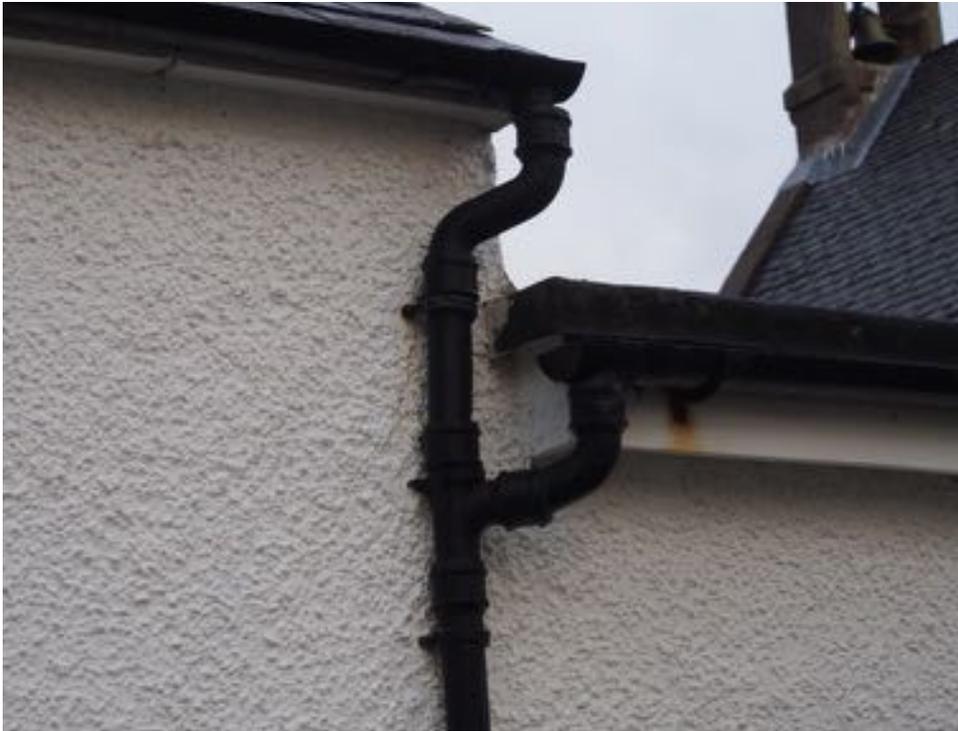
Loose downpipe on east side of extension

ELEMENT	DESCRIPTION	CONDITION	RECOMMENDED REPAIRS	PRIORITY	COST
<u>EXTERNAL</u>					
ROOFS	Pitched roof to church, flat roof to link and pitched roof to hall.				
Roof Coverings	Church roof - Ballachulish slate with zinc ridge Flat roof - bituminous felt roof covering. Hall roof - Welsh slates with zinc ridge	Front elevation - 1 missing slate at l.h.s and 2 loose at ridge Rear elevation - 1 missing at l.h.s and 2 loose at ridge Felt has been patched over link block and showing signs of ageing, however no defects apparent. Hall roof satisfactory	Replace loose and missing slates Felt roof has limited life and will need to be replaced in medium term.	E	300 (slate repair)
Flashings	Lead flashings to bellcote	Satisfactory			
Skews and parapets	Cast concrete skews to church	Top surface of skews have been repaired indicating a problem at some point in the past.	Monitor		
Rainwater goods	Church - UPVC and cast iron gutters and downpipes Hall - cast iron gutters and downpipes	Satisfactory Rusty bracket to downpipe and leak over door at south end of west elevation. Downpipes disconnected from gutter at east elevation. The flat roof over the link section does not have a gutter, presumably this roof falls towards wider flat roof, but there is a risk it could fall over the side of the roof.	Re-seal joint at leak over escape door, re-connect gutter at east side. Monitor rainwater disposal from flat roof.	E	200

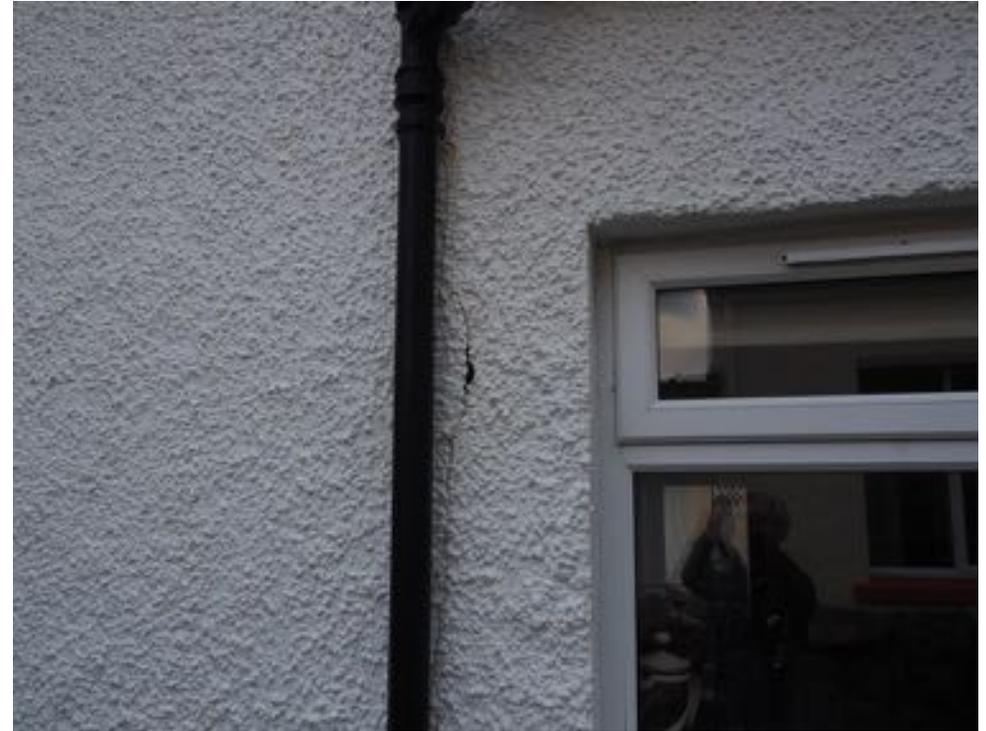
Crack behind downpipes on east elevation

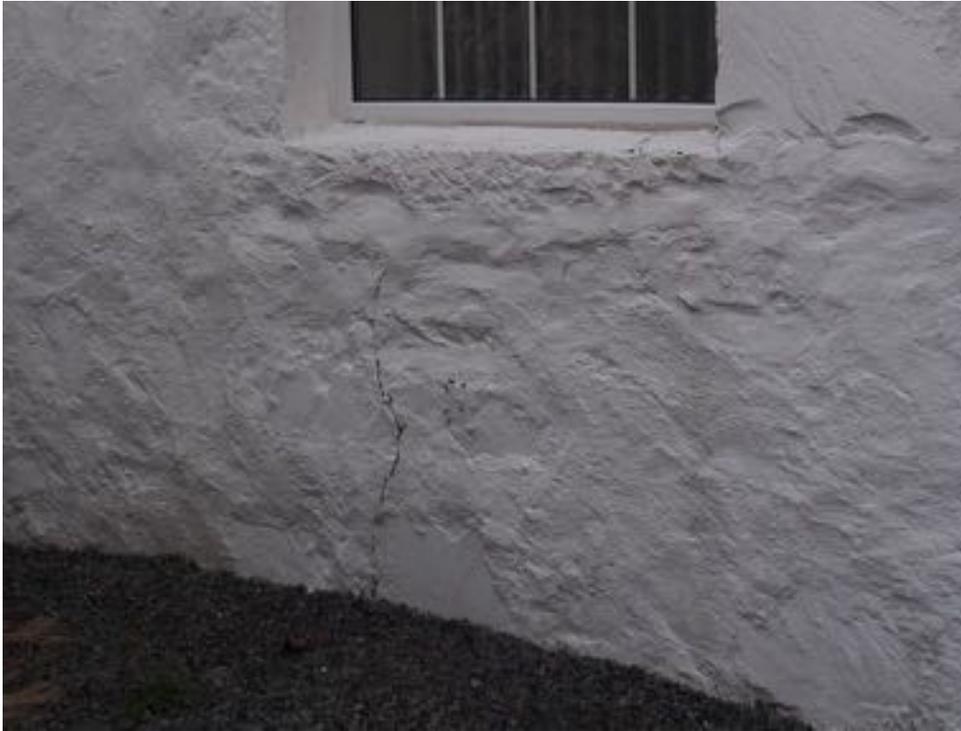
Crack under window east end of south side of church

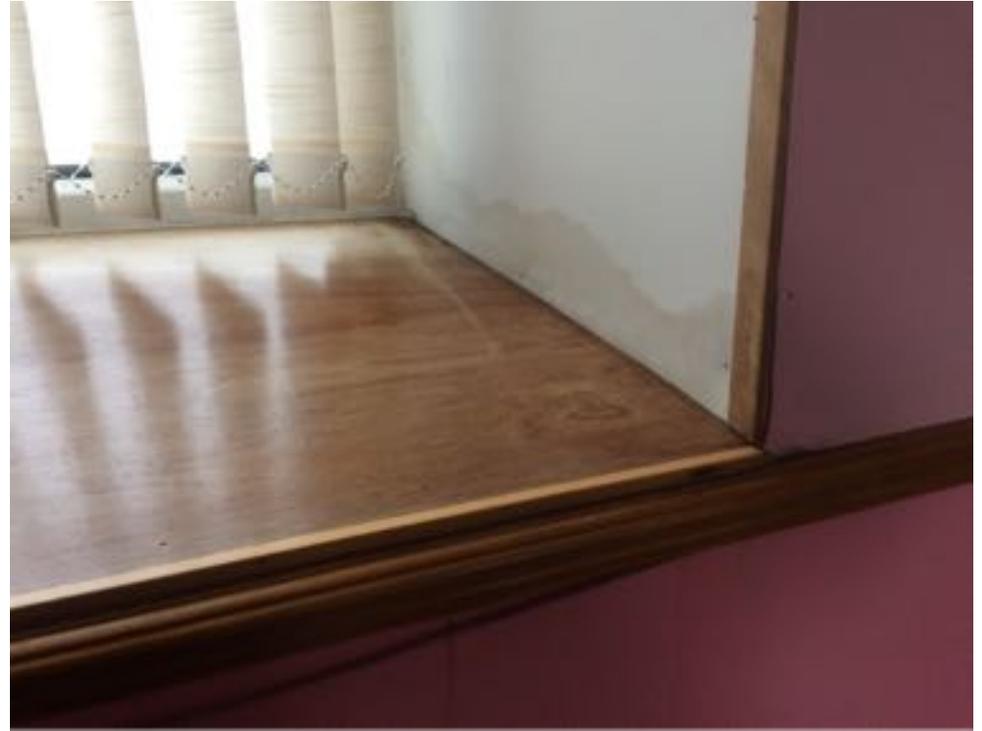
Damp ingress at window reveal south side of church

ELEMENT	DESCRIPTION	CONDITION	RECOMMENDED REPAIRS	PRIORITY	COST
ROOMS Partitions, finishes, cornices, doors, ironmongery etc CHURCH	Plasterboard lining with timber dado rail	Some damp staining to reveals at base of both windows on south side.	Check seal around perimeter of windows. The cill appears to be cement rendered stonework and consideration should be given to forming a suitable water proof cill with drip edge for example in concrete or stone slate.	E	400
CHURCH ENTRANCE HALL	Timber linings to dado height with plasterboard above	Generally satisfactory. Minor damp marks around door, likely to be caused by driving rain at perimeter of door	Check seal around edge of door.		
GALLERY	Plasterboard lined	Minor damp mark to ceiling and patch at south wall			
REAR ENTRANCE AND CORRIDOR	Plasterboard lined with flush ply doors opening off.	Generally satisfactory			
VESTRY	Plasterboard lined	Minor damage to wall finish	Touch up	D	100

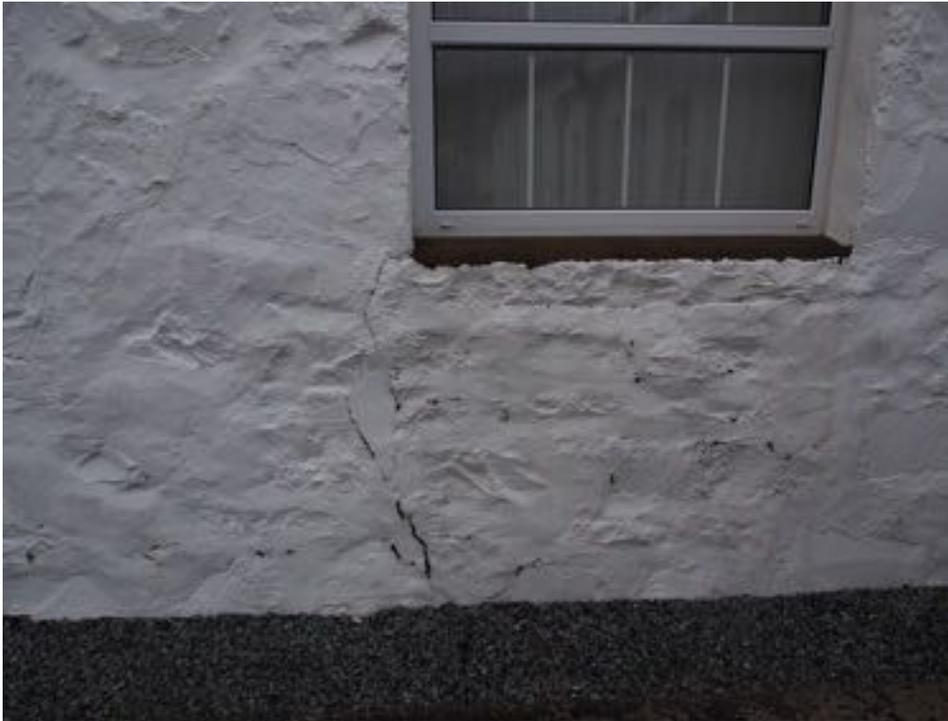
Crack under window west end of south side of church

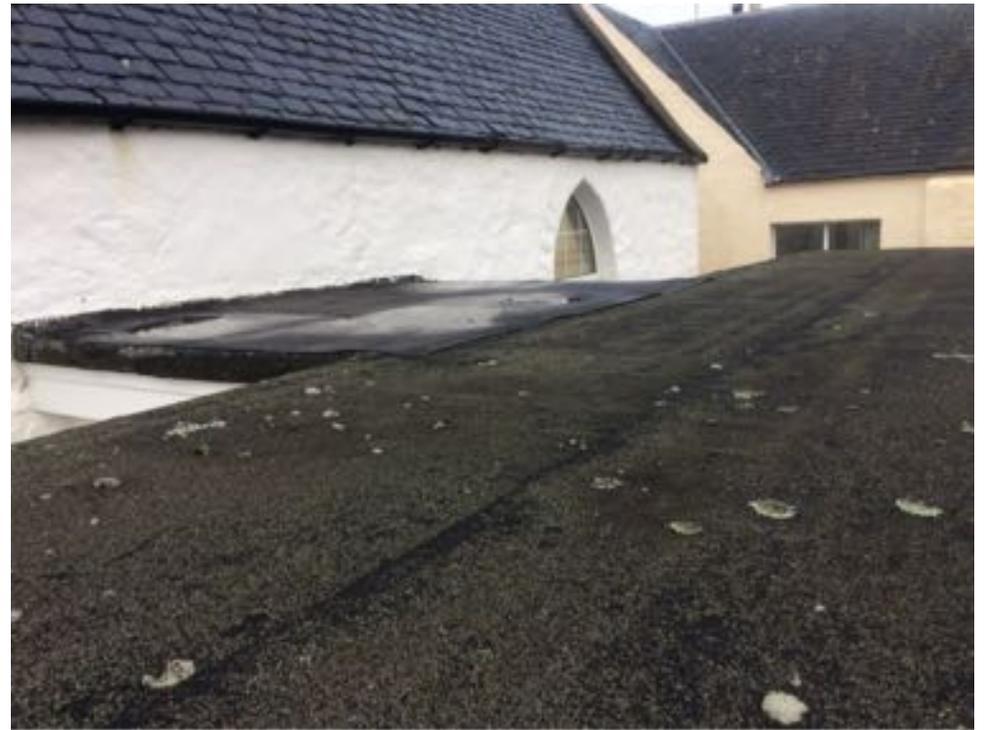
Flat roof of link block

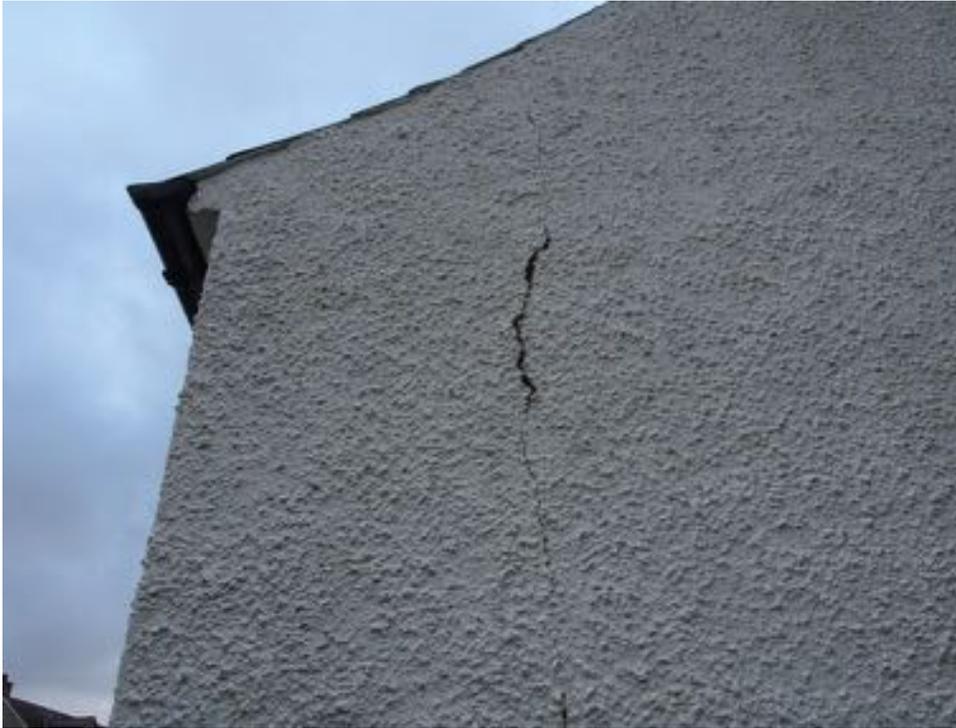
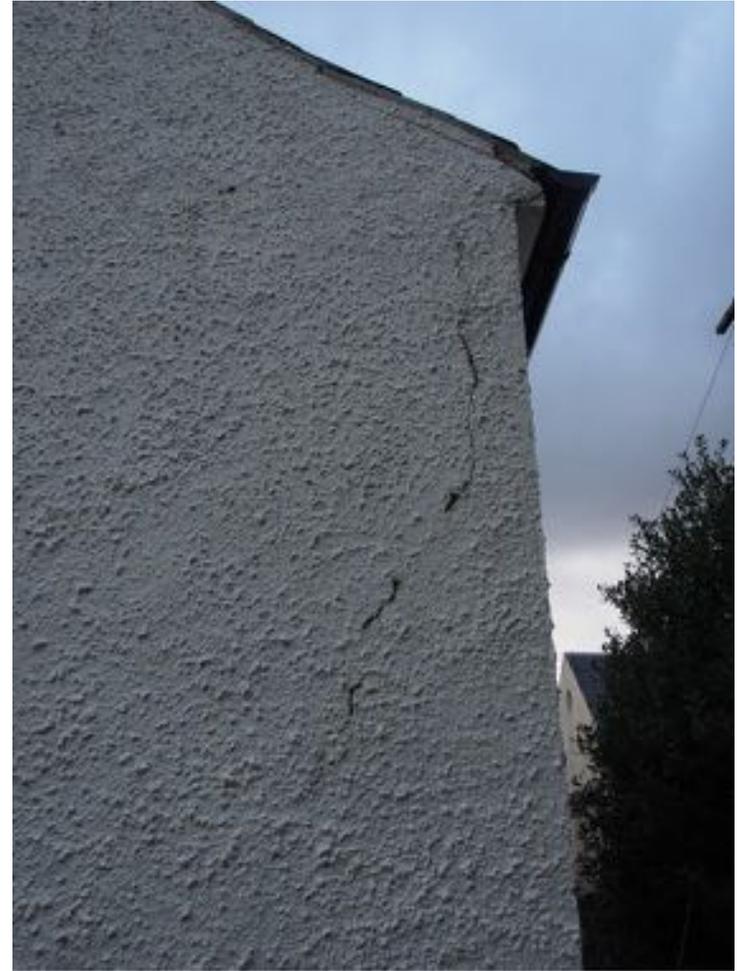
Cracks at south side of hall
