Quinquennial Report

Kilmore Church

Church of Scotland Lochcarron and Skye Presbytery
November 2016

PROPERTY KILMORE CHURCH

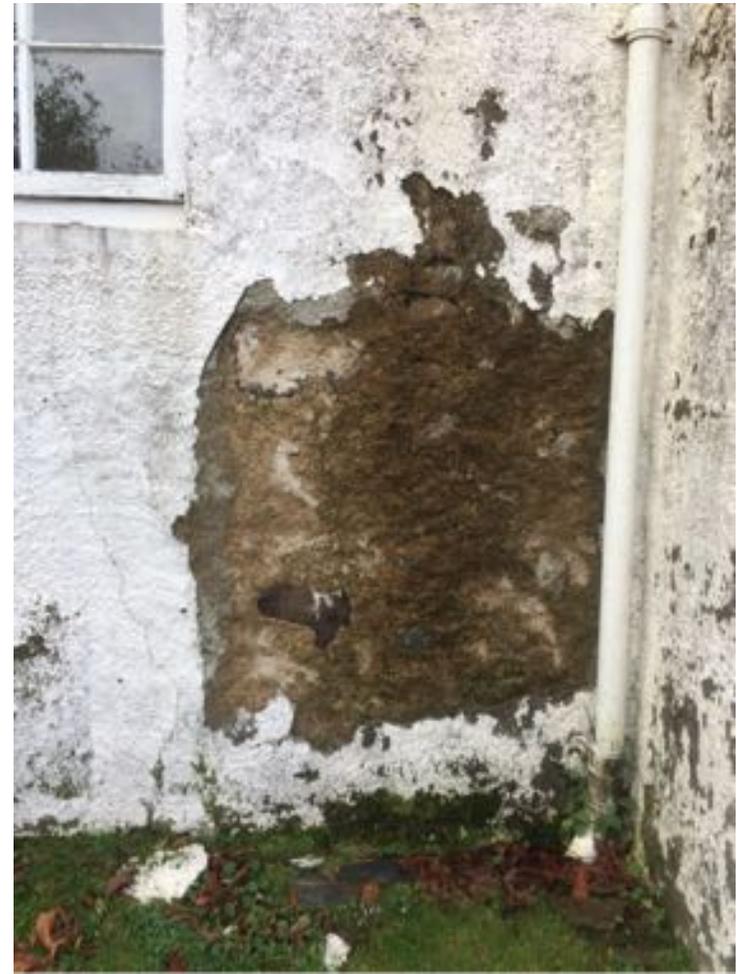
Defective render on East elevation

ELEMENT	DESCRIPTION	CONDITION	RECOMMENDED REPAIRS	PRIORITY	COST
Wall structure	Stonework walls with buttresses to east and west elevations	There are minor cracks above and below windows on both east and west elevations at the north end of the building. In addition there have been cracks on the south gable end which have been cement pointed in the past and do not appear have re-opened. There is minor plant and moss growth on the buttresses. The sloping faces of the buttresses show some cracks and defects in the pointing. This may account for or contribute to the damp ingress visible internally around the window at the south end of the west elevation and in the niches behind the middle buttresses.	Remove vegetation and repoint cracks in buttresses	U	500
Wall finish	Cement render on east and north elevations	Large areas of failed render on east side. Render at high level on north gable also looks suspect.	Pick off existing render finish and re-render. Consideration may be given to use of lime render. Check render ingress to windows.	U	15,000

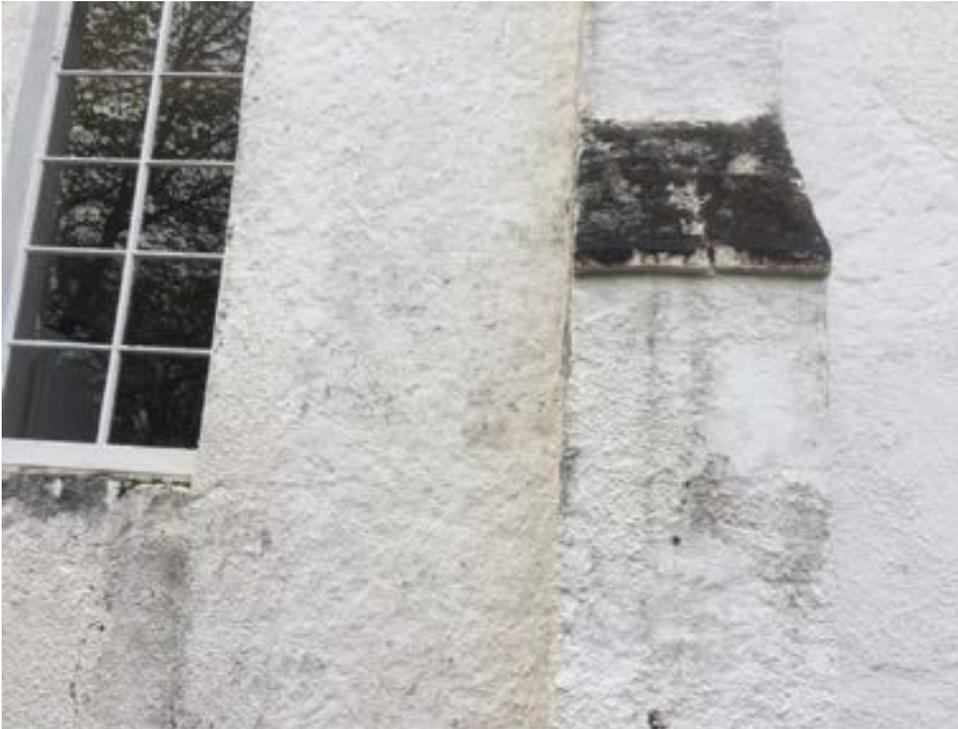
Buttress on East elevation, note note damp on sloped surface and crack under window

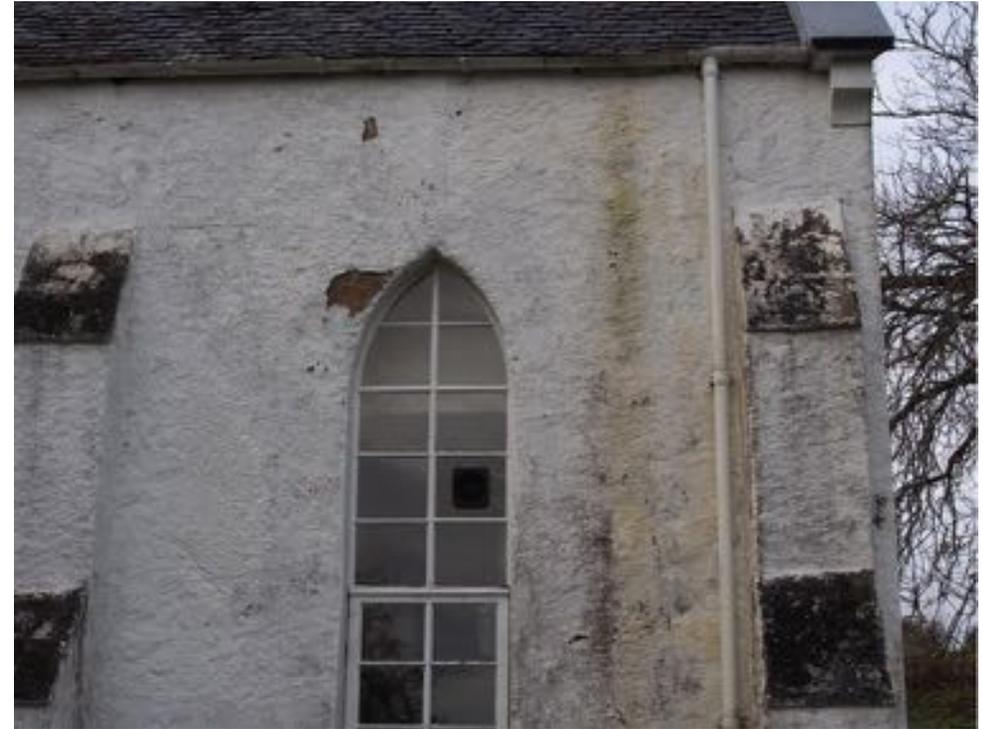
Defective render and crack above window, damp staining from defective gutter on East elevation

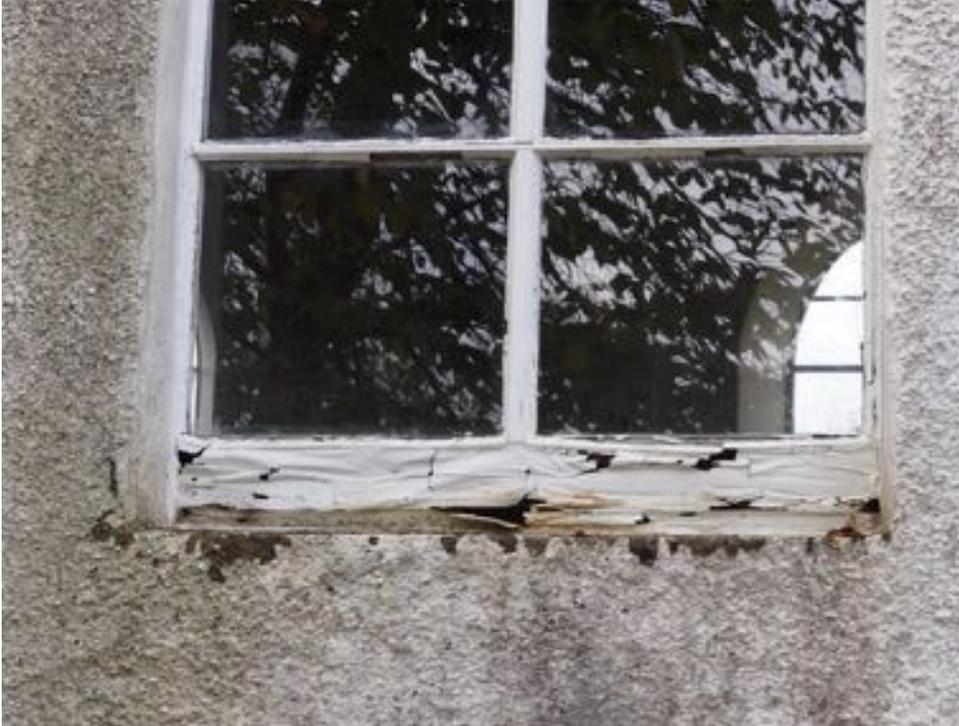
Rotten bottom rail to window on East elevation,
note flat window ledge without cill to shed water

ELEMENT	DESCRIPTION	CONDITION	RECOMMENDED REPAIRS	PRIORITY	COST
DOORS AND WINDOWS	Timber single glazed fixed lights (openable in kitchen) with simple astragal divisions. Timber boarded front and rear doors	Windows are in poor condition with rotten bottom rails and defective putty. On the south gable one of the bottom panes is so poor that the glass is no longer secured in position. The window cill detail contributes to this problem as there is almost no fall, allowing water to sit and damage the base of the window. Doors are in moderate condition though not well sealing, and elaborate ironwork hinges are showing rust.	Replace windows. Clearly this will be costly and it may be necessary to carry out temporary repairs in the meantime. Most urgent is the south gable window. Consideration should also be given to the cills. On the west, north and south sides the cills are dressed stone at a very shallow angle which could be improved with a lead sub-cill and slight upstand. On the east side the cill is formed by the render and could be improved with an angled slate or stone cill.	U	12,000 (south elevation and repairs)

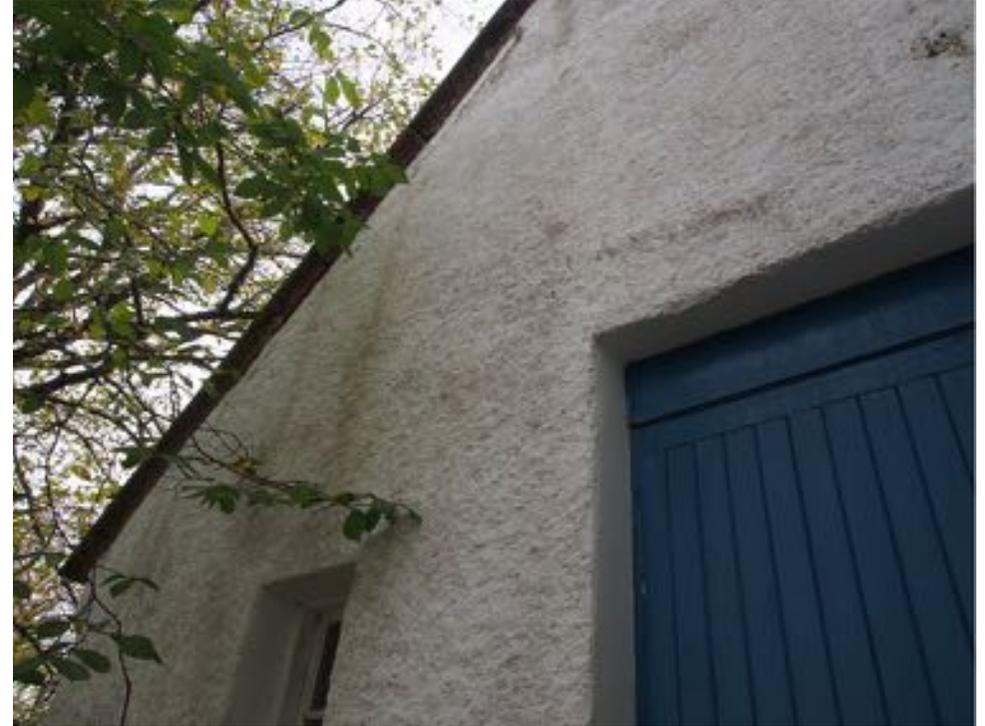
North side of lean-to showing gaps in skew and
defective render

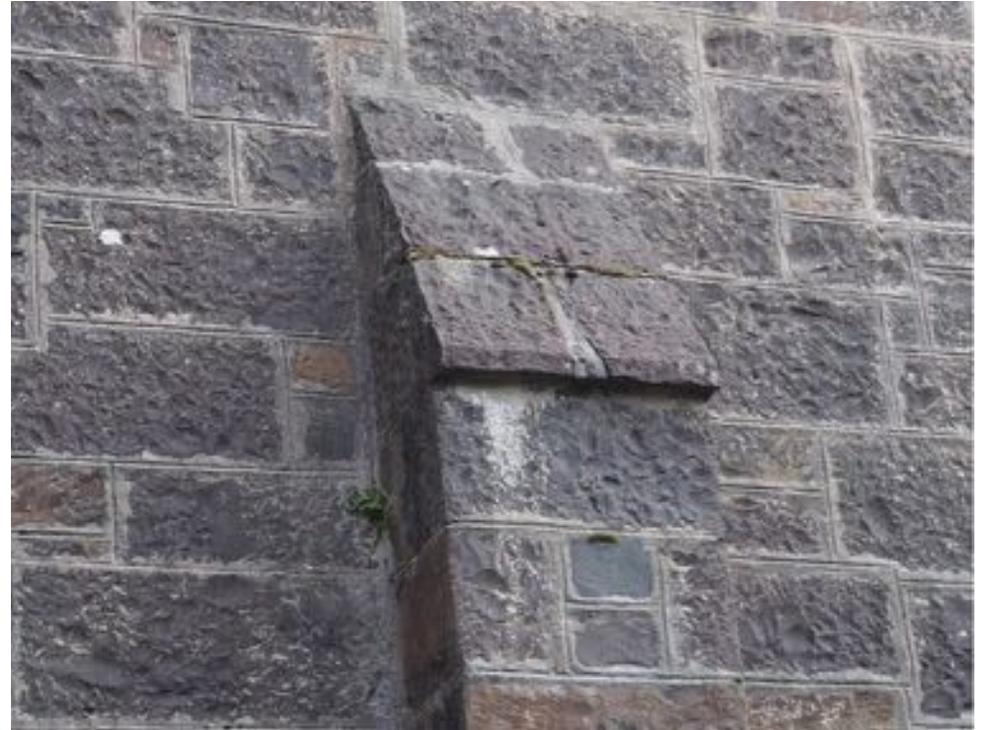
Top of buttress showing slight defects to pointing and moss / vegetation growth

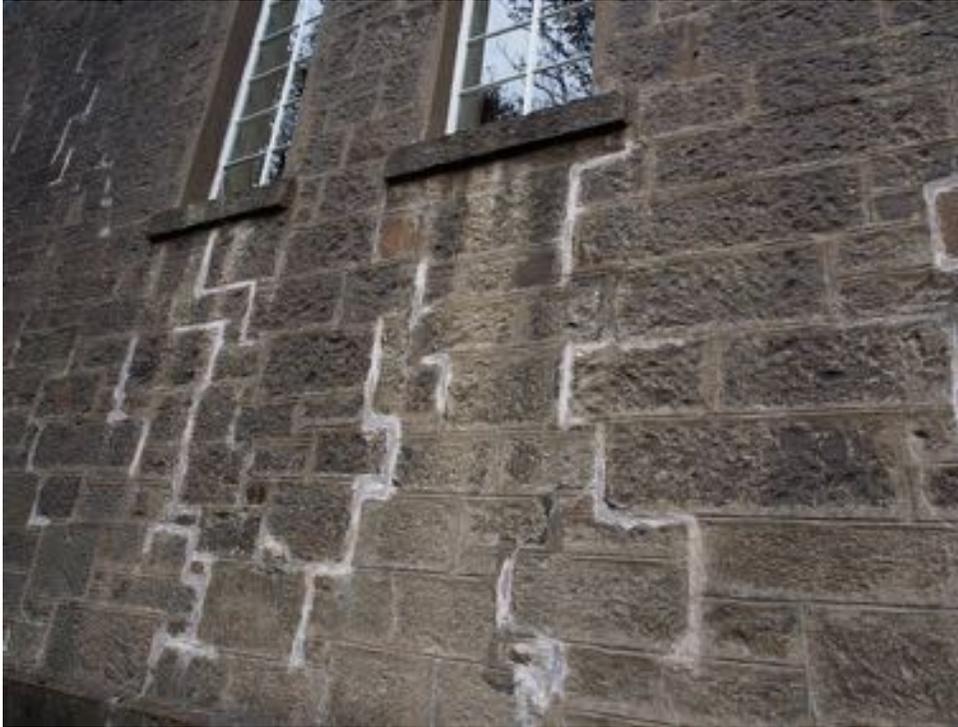
Cracks in South gable pointed up

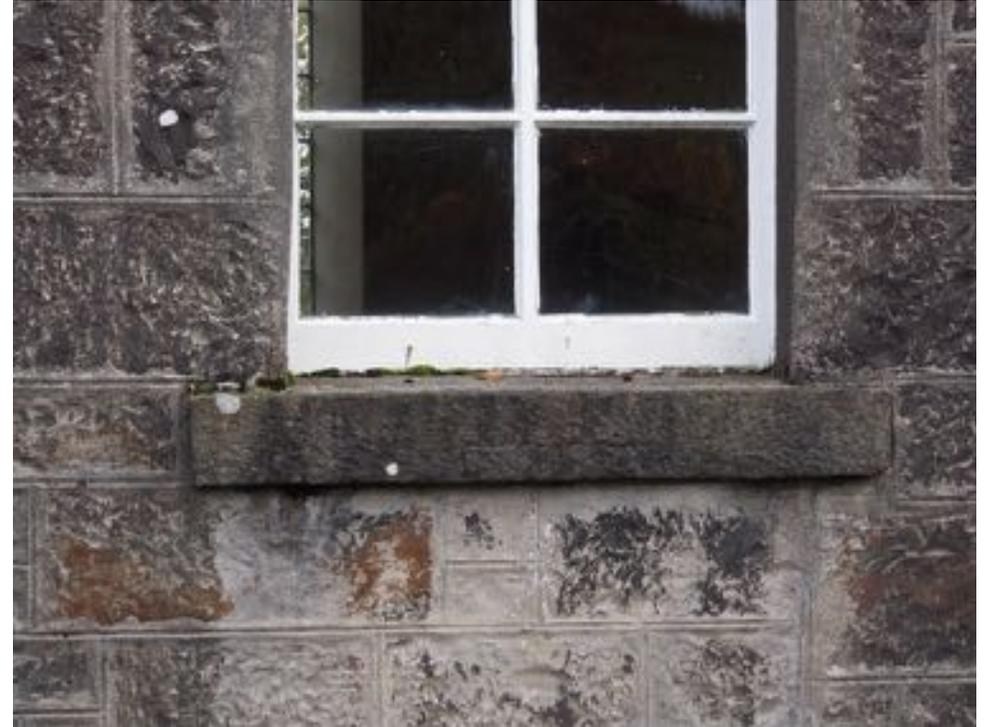
Window cill on West elevation is very flat and has some moss growth

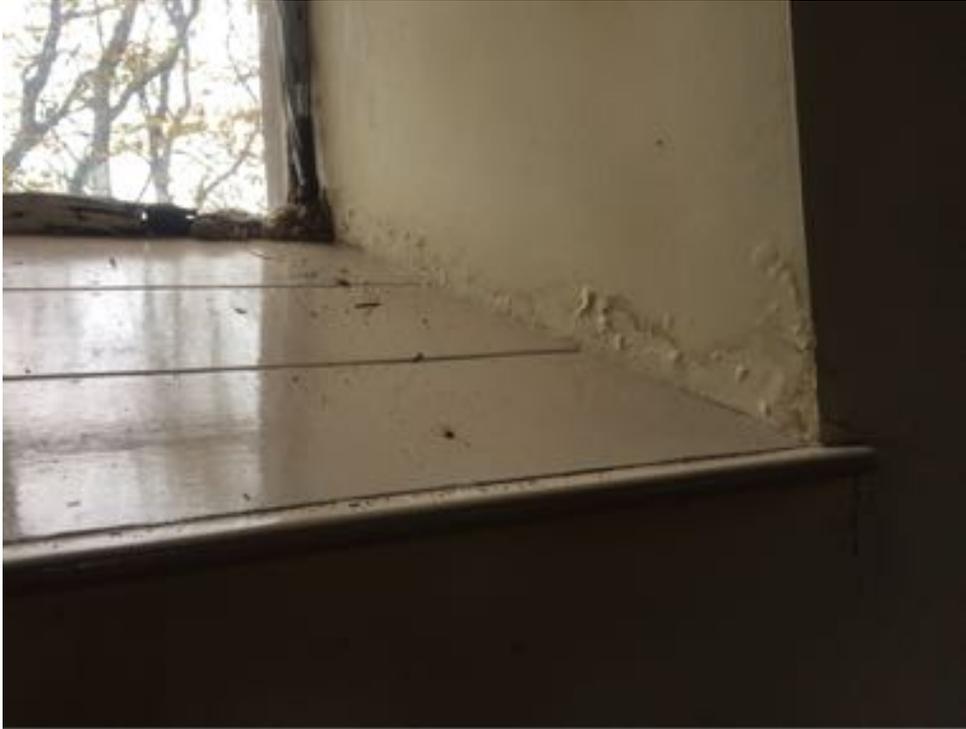
Defective window frame and water ingress at base of window on South gable

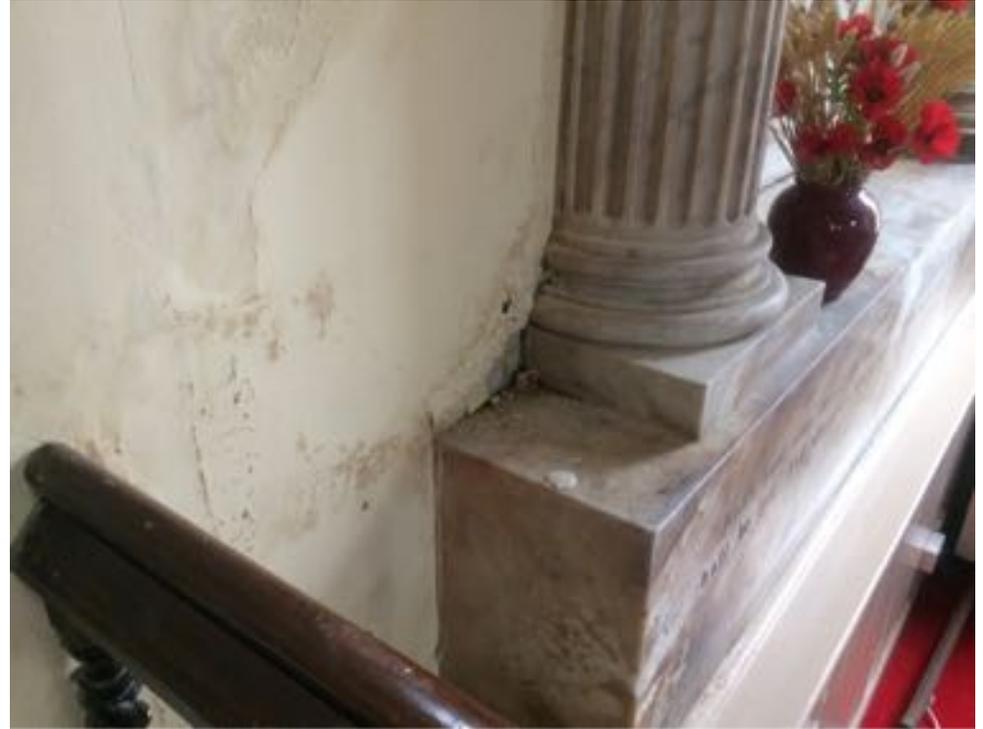
Dampness in wall adjacent to monument on right hand side of pulpit

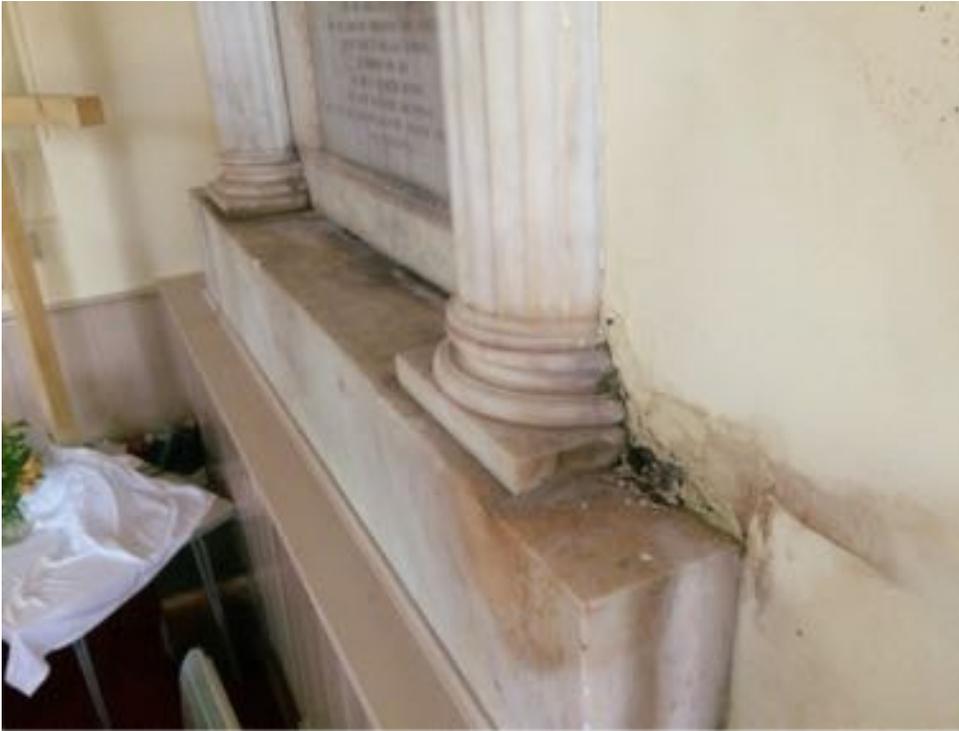
Dampness in wall adjacent to monument on left hand side of pulpit

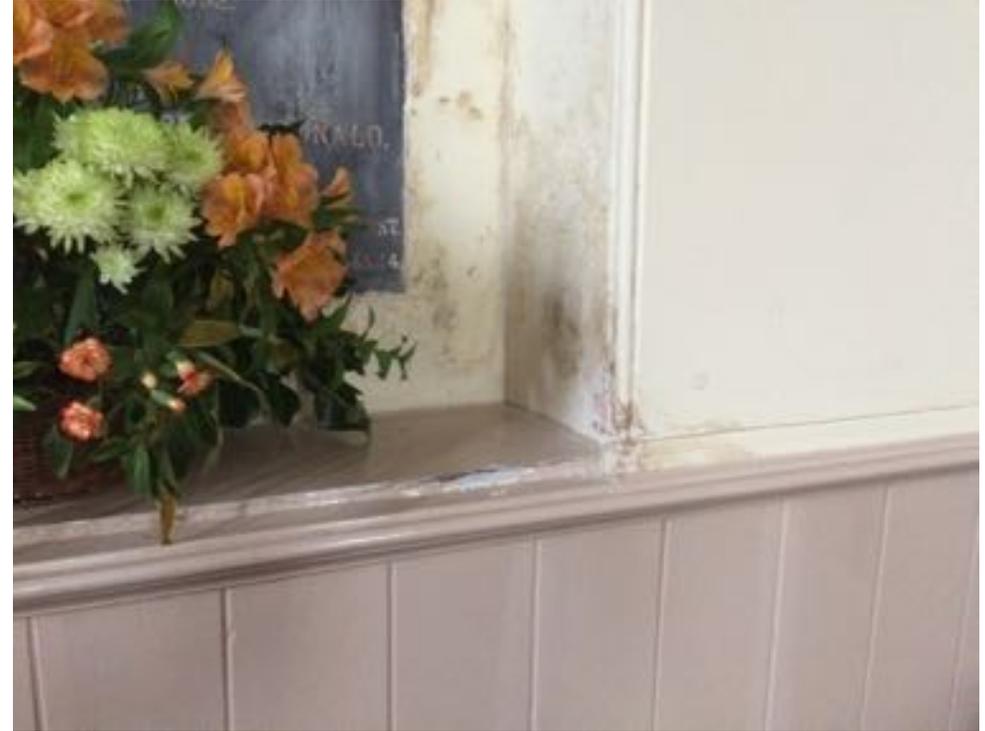
Dampness in wall at niche on west elevation. Note buttness is immediately behind the alcove

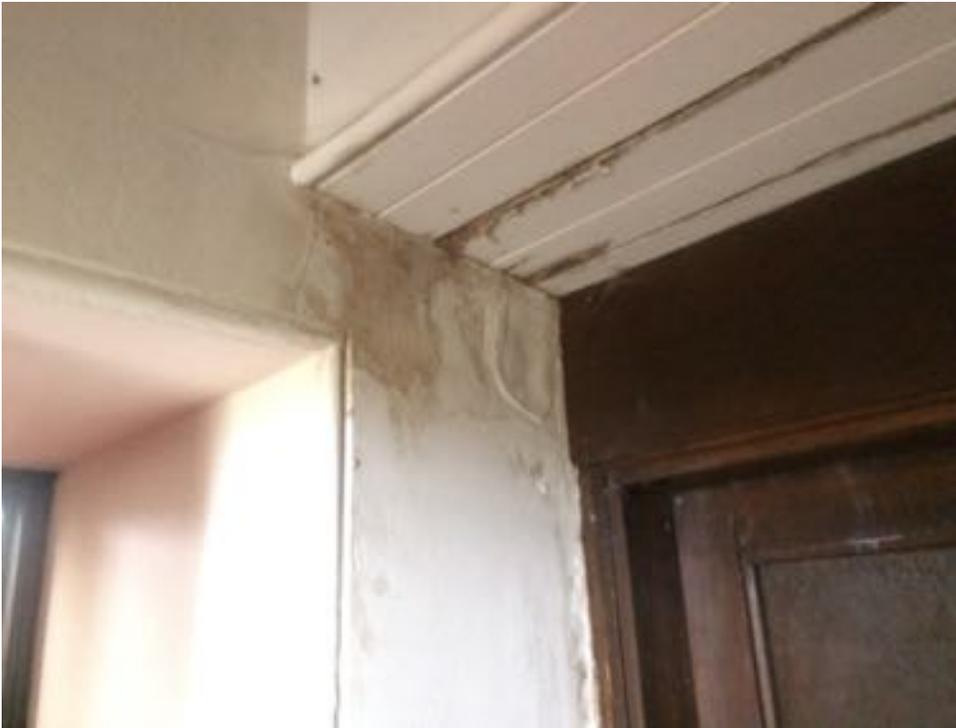
Dampness over external door and w.c. door in lean-to, associated with pointing to skew and render on external wall above

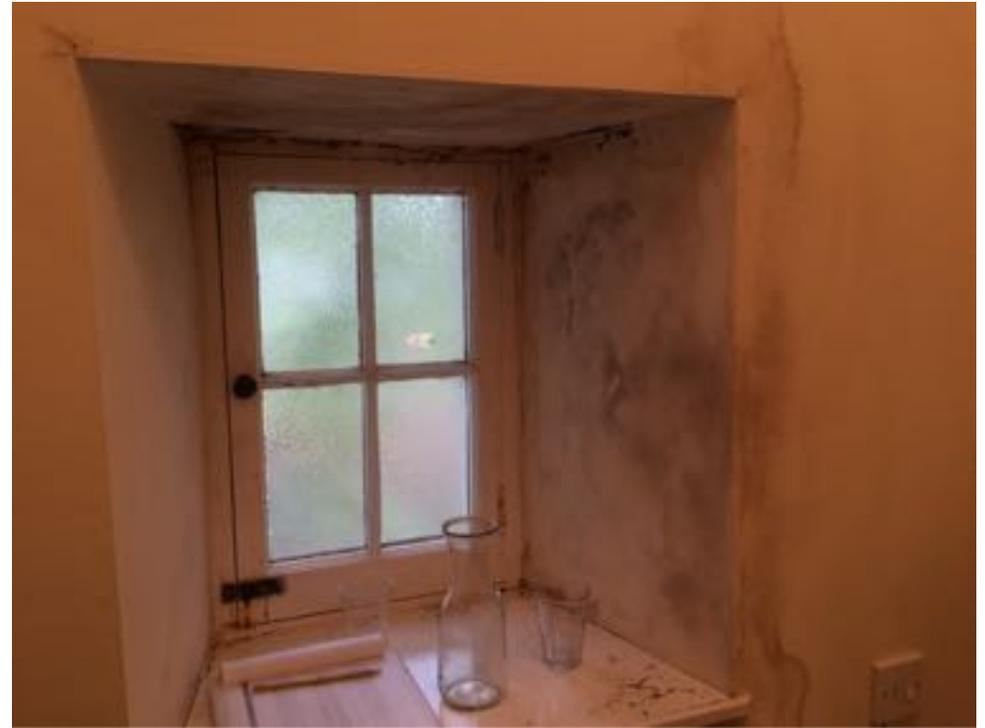
Dampness in external wall of rear w.c.

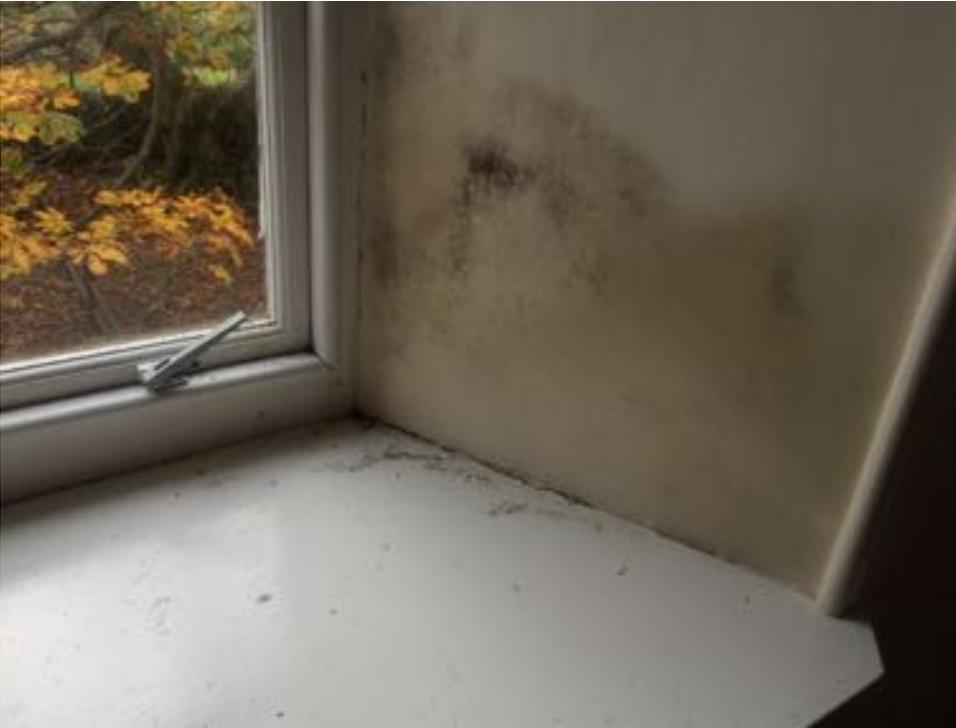
Dampness at South facing window in vestry

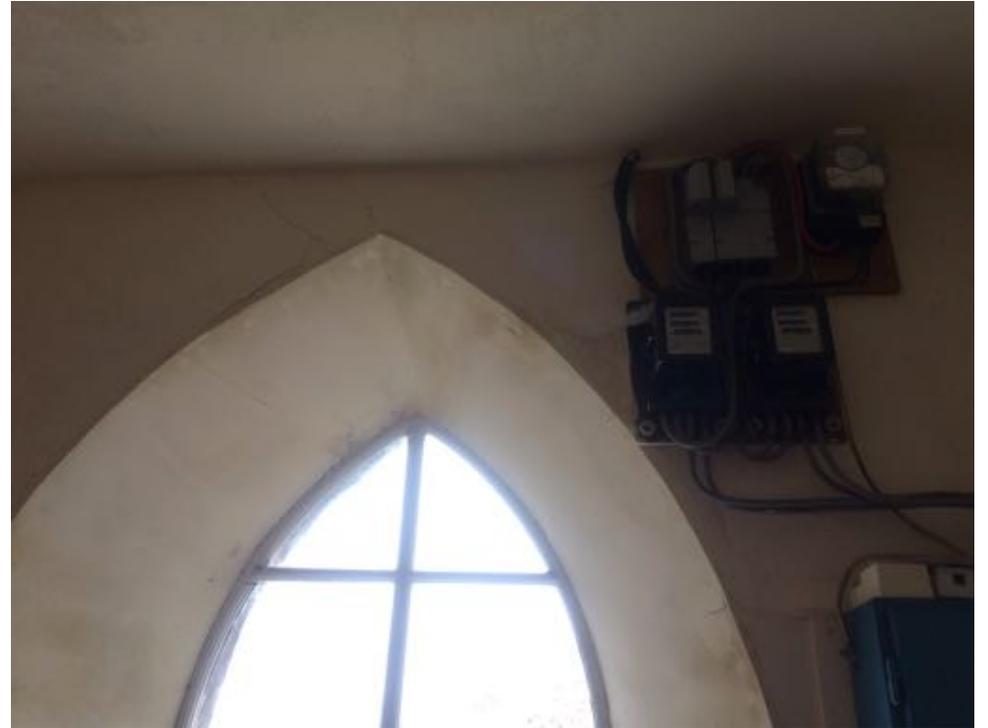
Dampness and cracking adjacent to window in vestry

ELEMENT	DESCRIPTION	CONDITION	RECOMMENDED REPAIRS	PRIORITY	COST
VESTRY	Lath and plaster	Damp ingress and cracking around window. Base of south facing wall and adjacent flooring showing dampness	External repairs to window and cill noted above. Cut out damaged timber and plaster and replace.	E	500
REAR LOBBY	Lath and plaster	Dampness around and over door opening	External repair to skew noted above. Cut out damaged finishes and replace. Open up to investigate condition of lintel.	E	300
REAR WC	Lath and plaster	Considerable damp ingress around and above window associated with skew defect.	External repair to skew noted above. Cut out damaged finishes and replace. Open up to investigate condition of lintel.	E	300
MEETING ROOM 1 (east side)	Timber lining to dado with lath and plaster above. Folding / sliding separating screen	Some minor cracking in ceiling and damp ingress under window, probably associated with defective render and cill. There is also a crack either side of the door. Door knob loose.	Fill cracks when decorating and tighten ironmongery.	D	200

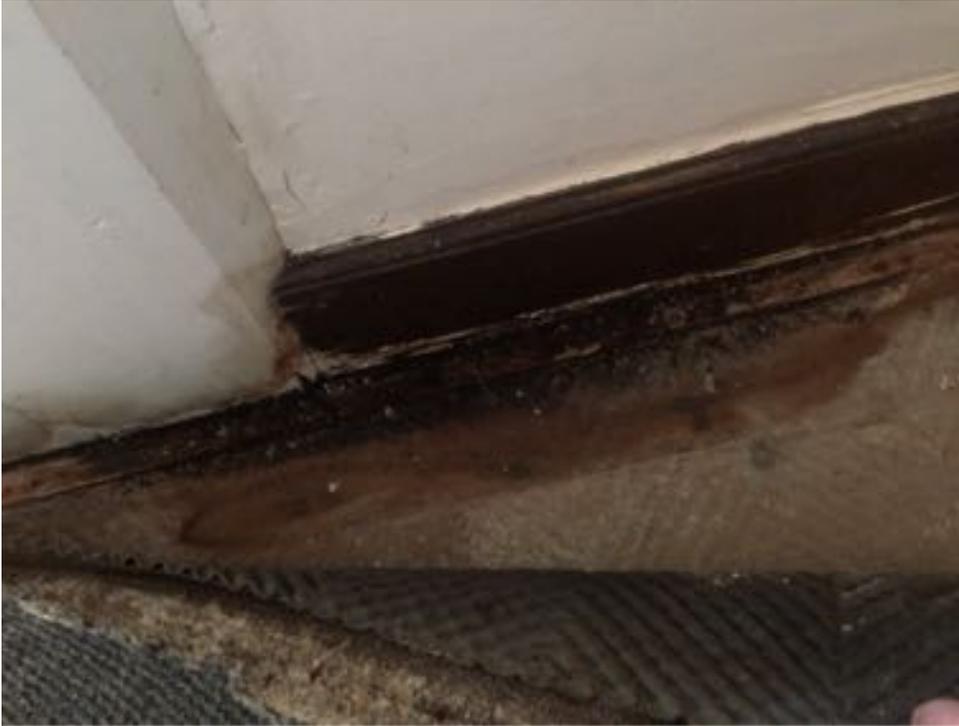
Dampness affecting floor and wall below window in vestry
