Quinquennial Report

Broadford Church

Church of Scotland Lochcarron and Skye Presbytery
October 2016

PROPERTY BROADFORD CHURCH

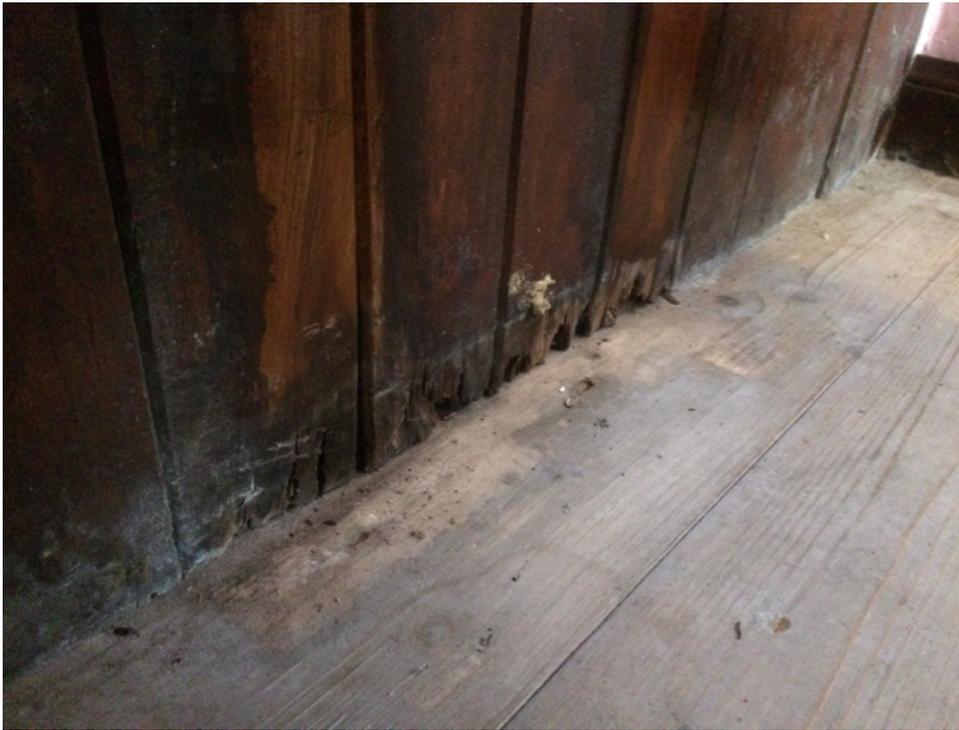
CHURCH SPACE	Timber lining to dado height with plasterboard above.	Some moisture meter readings in bottom of timber linings, with minor area of rot apparent at the base of the west wall.	Dampness associated with cracks and boss sections in render, and possible rising damp from solum. Carry out external repairs and monitor. There is a possibility of installing an electro-osmotic damp proof course in the future, however this would be very disruptive to floor and walls.		
REAR CORRIDOR	Timber lining to dado height with plasterboard above.	Minor dampness around external door	Fix external gutter as noted above

Damp affected lining boards on south elevation

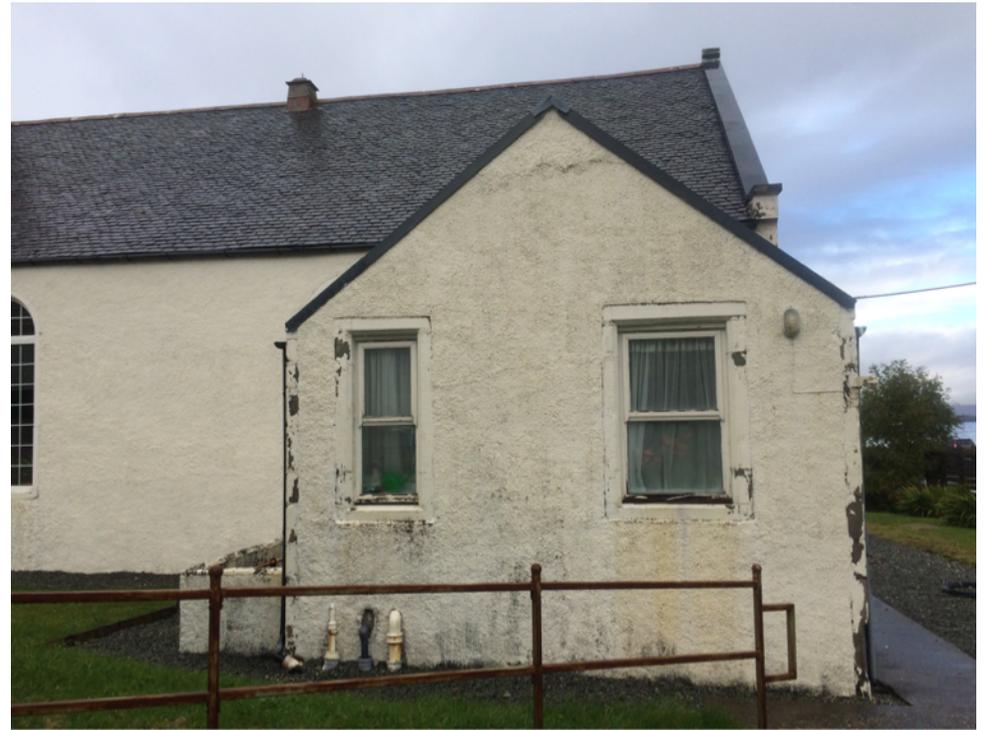
ELEMENT	DESCRIPTION	CONDITION	RECOMMENDED REPAIRS	PRIORITY	COST
EXTERNAL WOODWORK					
DOORS AND WINDOWS	UPVC windows to church UPVC front and rear door Timber windows to rear wing	UPVC windows and doors appear reasonable Timber windows in poor condition	Replace 2 no. timber windows	D	800
EXTERNAL PAINTING	Masonry paint to stonework and render walls	Moderate to poor condition, in particular on rear wing and above rear door.	Re-paint	D	3,500
EXTERNAL DRAINAGE	Downpipes discharge to gulleys. SVP concealed and terminates at slate vent.	At there rear wing, the downpipe stops short of the gulley	Extend downpipe and replace gulley grating.	D	200
GARDEN AND GROUNDS	Gravel entrance area, grass to rear garden ground, hedge and a number of mature trees				
FENCES, GATES, WALLS	Rendered blockwork to front and north boundary	Minor cracks to front. Substantial crack to wall at west side	Pick and point cracks	D	500

Rotten timber window frames and poor paint finish on south wing

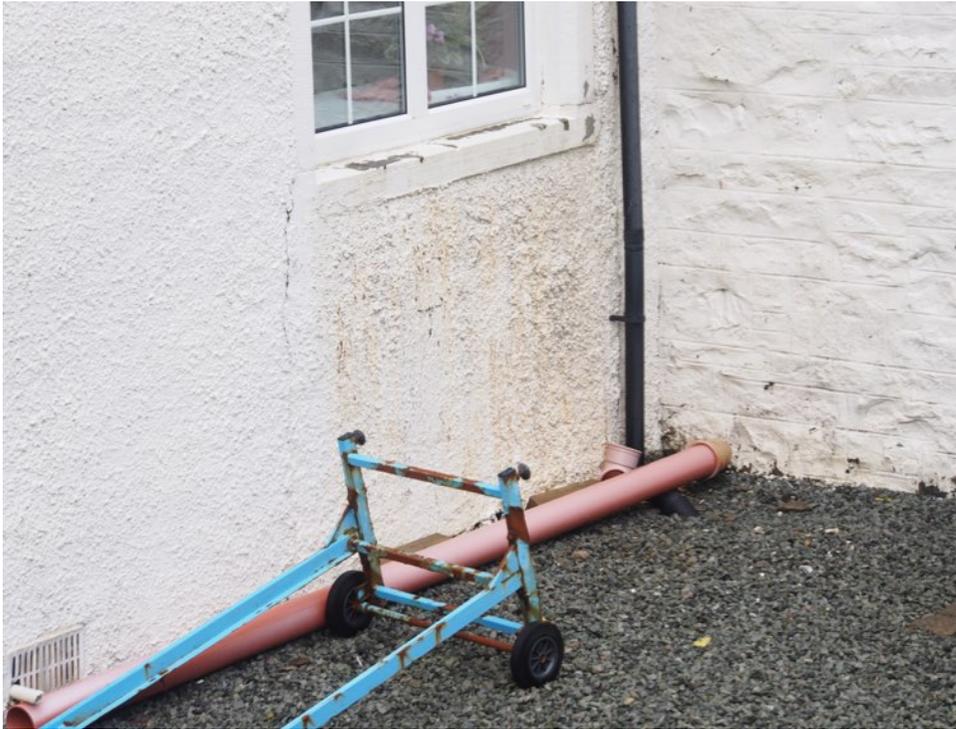
ELEMENT	DESCRIPTION	CONDITION	RECOMMENDED REPAIRS	PRIORITY	COST
Rainwater goods	UPVC gutters and downpipes	Generally satisfactory. Spillage from gutter at rear elevation south end. Fall on north side of wing needs to be adjusted.	Adjust fall of gutter at rear elevation, and ensure it is suitably located. Seal joint and adjust fall on north side of extension where there is a drip.	E	300
Spire, bellcote, finials	Stone bellcote at north gable end Stone finial on south gable	Minor gaps in pointing of bellcote and apparent crack to stone cope under bell. No sign of water ingress.	Minor re-pointing	E	600
WALLS	Masonry walls with tooled sandstone quoins and margins				
Wall structure	Stonework	Minor cracks below both rear windows, apparent in render.	Minor picking and pointing	E	500
Wall finish	Stonework is flush pointed and painted on the north and east elevations. Wet dash render on south and west elevations.	Boss render below both rear (south) windows	Patch repair	E	500

Cracked and defective render below window at south elevation

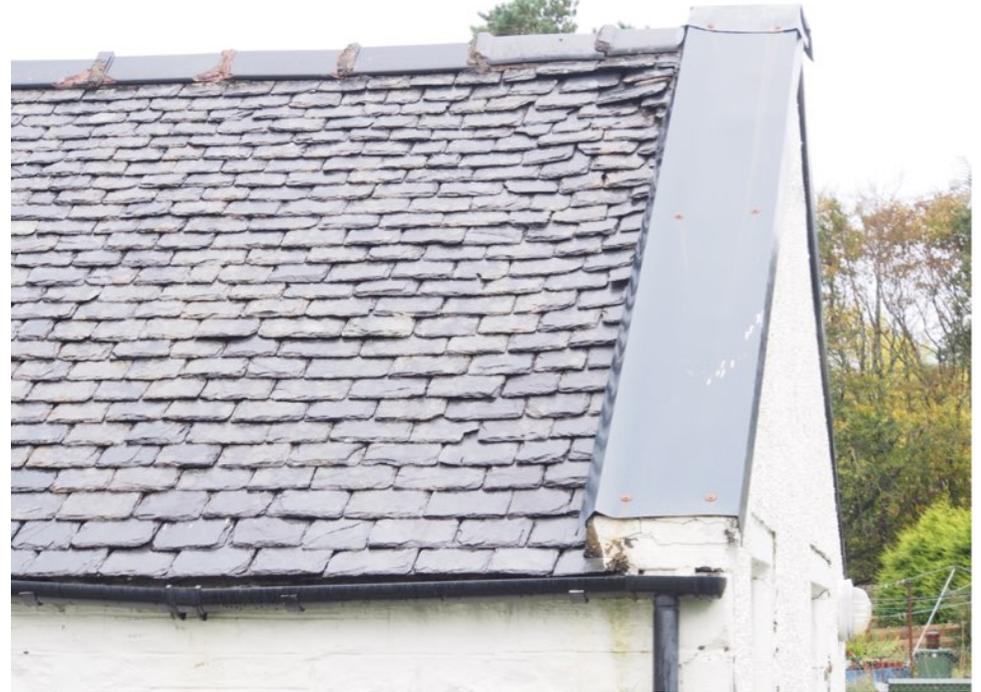
ELEMENT	DESCRIPTION	CONDITION	RECOMMENDED REPAIRS	PRIORITY	COST
<u>EXTERNAL</u>					
ROOFS	Pitched slate roof				
Roof Coverings	Ballachulish slate with clay ridge tiles	3no. slipped slates at rear roof and slates disturbed or loose at apex of rear wing roof. 1 no. broken ridge tile on main roof, several capping pieces broken on ridge of extension roof. The north facing front roof has quite a lot of moss growth, this is not necessarily a problem unless there is a risk of gutters and downpipes getting blocked.	Replace loose slates. Repair broken ridge tiles	D	500
Flashings	Lead valleys at junction of extension roof with main roof	Satisfactory			
Skews and parapets	Stone skews with aluminium cappings.	No evidence of problems

Loose slates and damaged ridge tiles on South wing

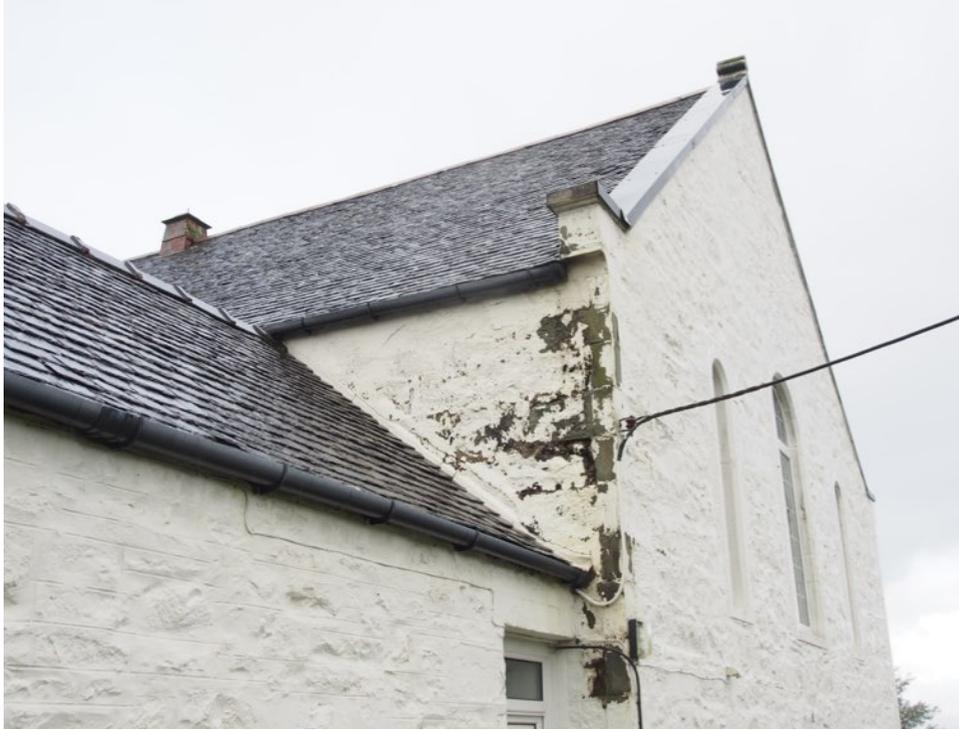
Damaged paint finish at South East corner of main church

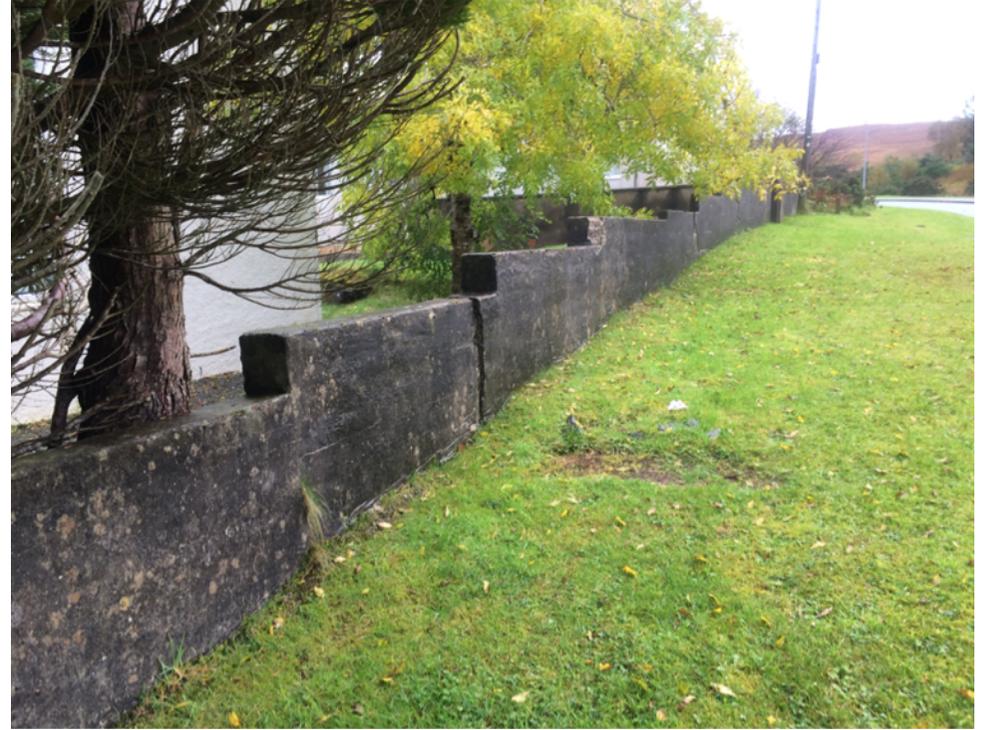
Cracks to boundary wall at west end
