Quinquennial Report

Kilmore Church

Church of Scotland Lochcarron and Skye Presbytery
November 2016

PROPERTY KILMORE CHURCH

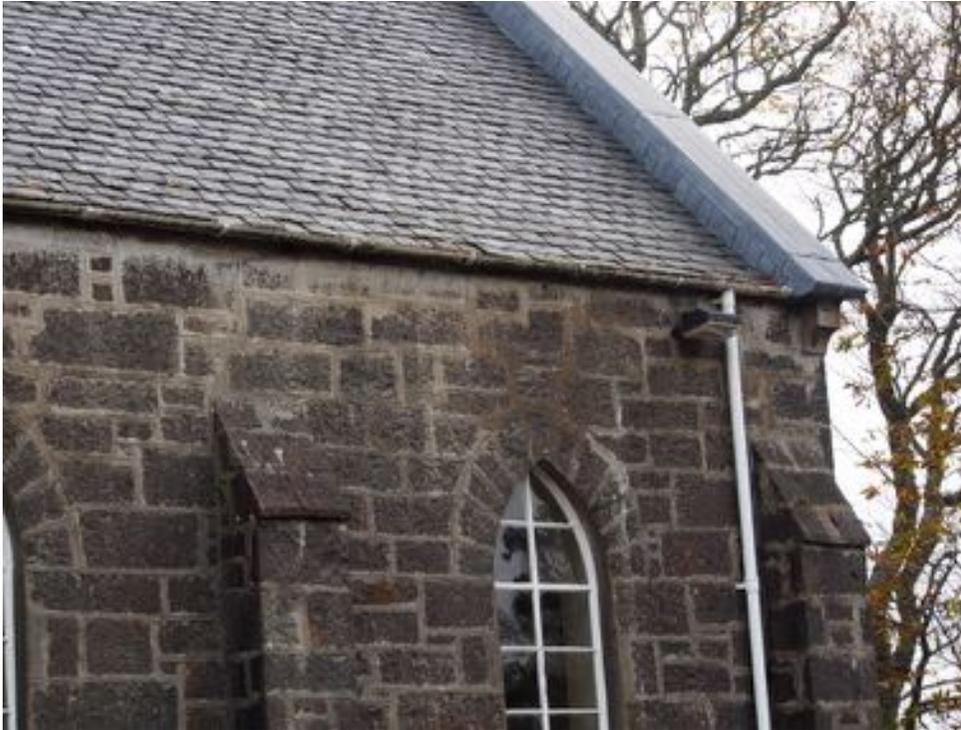
West elevation buttresses and window head

ELEMENT	DESCRIPTION	CONDITION	RECOMMENDED REPAIRS	PRIORITY	COST
Wall structure	Stonework walls with buttresses to east and west elevations	There are minor cracks above and below windows on both east and west elevations at the north end of the building. In addition there have been cracks on the south gable end which have been cement pointed in the past and do not appear have re-opened. There is minor plant and moss growth on the buttresses. The sloping faces of the buttresses show some cracks and defects in the pointing. This may account for or contribute to the damp ingress visible internally around the window at the south end of the west elevation and in the niches behind the middle buttresses.	Remove vegetation and repoint cracks in buttresses	U	500
Wall finish	Cement render on east and north elevations	Large areas of failed render on east side. Render at high level on north gable also looks suspect.	Pick off existing render finish and re-render. Consideration may be given to use of lime render. Check render ingress to windows.	U	15,000
